CITY OF IDAHO FALLS

Elevated Water Tower

Well Site Deficiency Evaluation

Water Tower Deficiencies

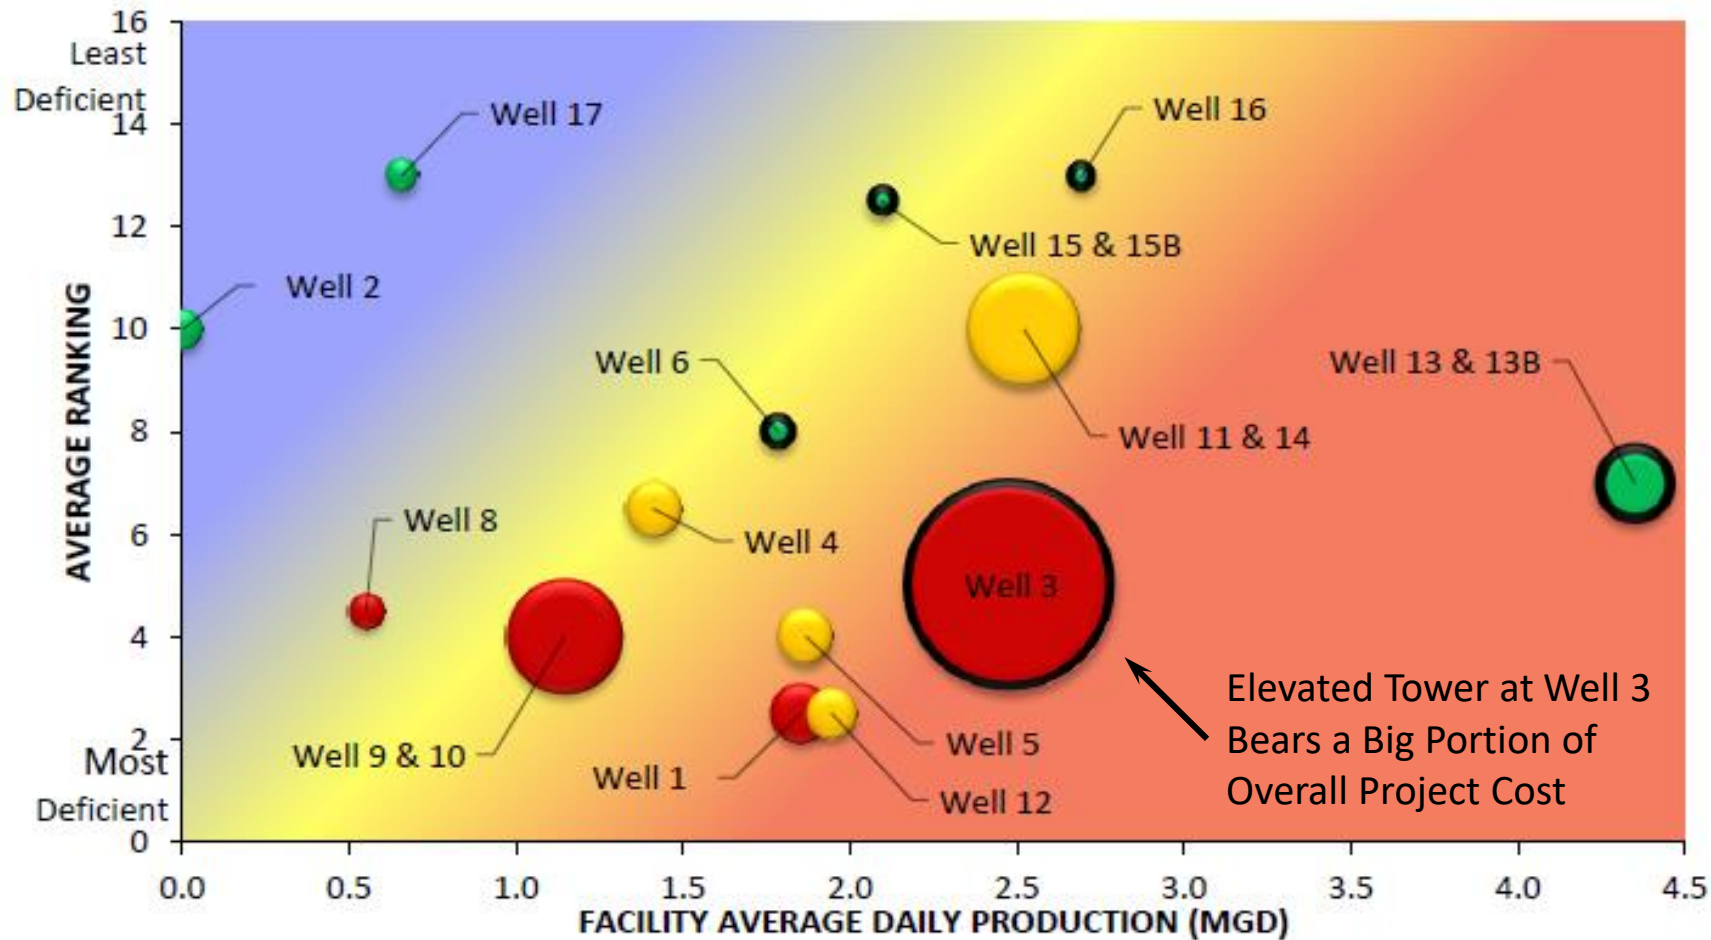
Figure 6-1
Well Ranking vs Average Daily Production

Figure 6-1 Key

- Size of circle indicates relative cost of improvements.
- Black outer bands indicate wells used year-round.
- Color of circle indicates well facility risk of failure.

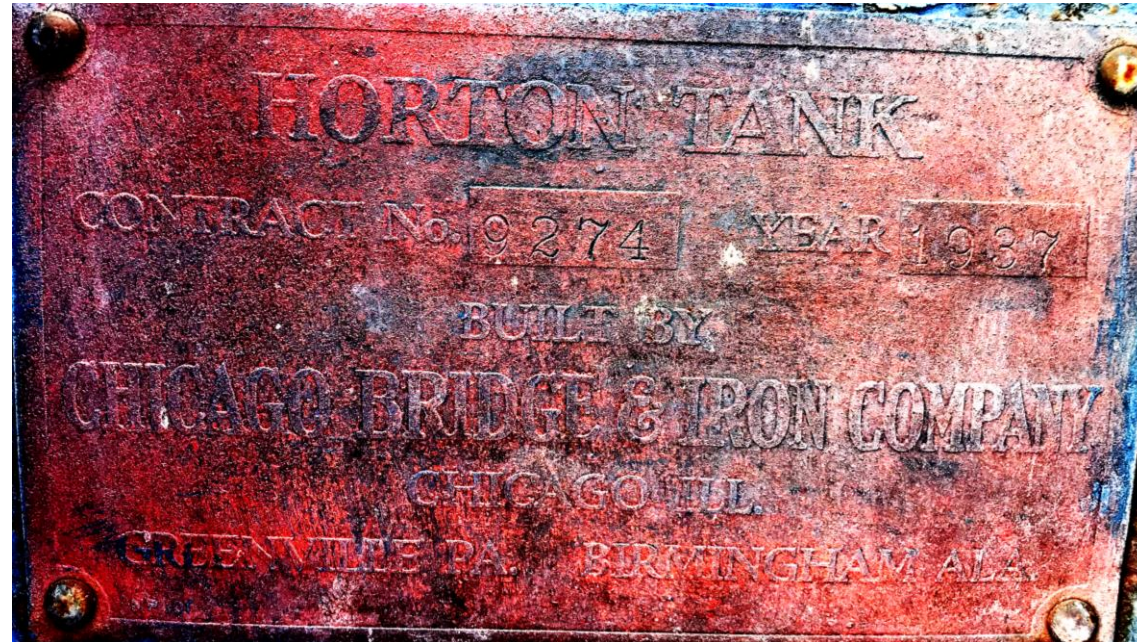
Elevated Tower Construction Drawing

- Constructed in 1937; 82 years old
- Built by Chicago Bridge & Iron Company
- Style Called "Horton Tank," Named After Company Owner
- Holds 500,000 gallons; max height of 185' at peak
- Original color: silver/gray; colored red, white and blue for 1976 Bicentennial

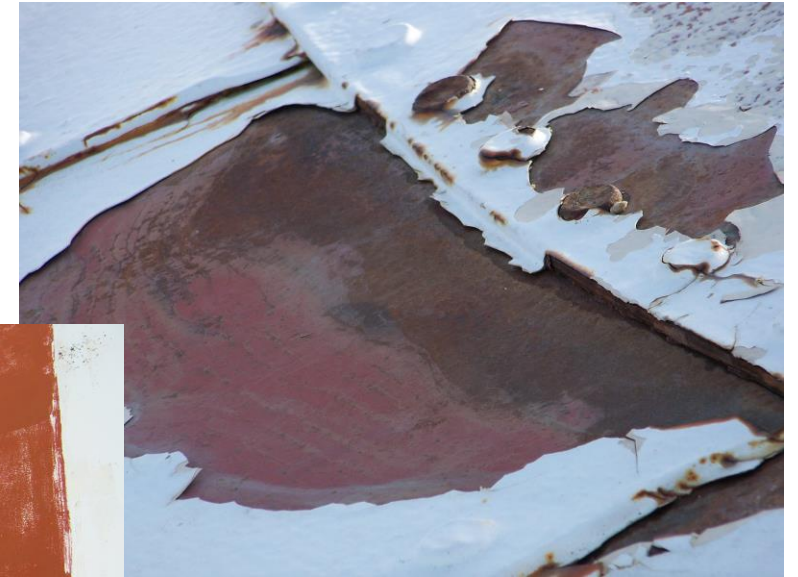
Tower Roof

- Paint
 - Base paint coats losing adhesion
 - 1997 CH2M Hill report:
 - High lead content in base coat paint
 - Recommended sandblasting & recoating tower
 - Roof top-coated white for \$24,890

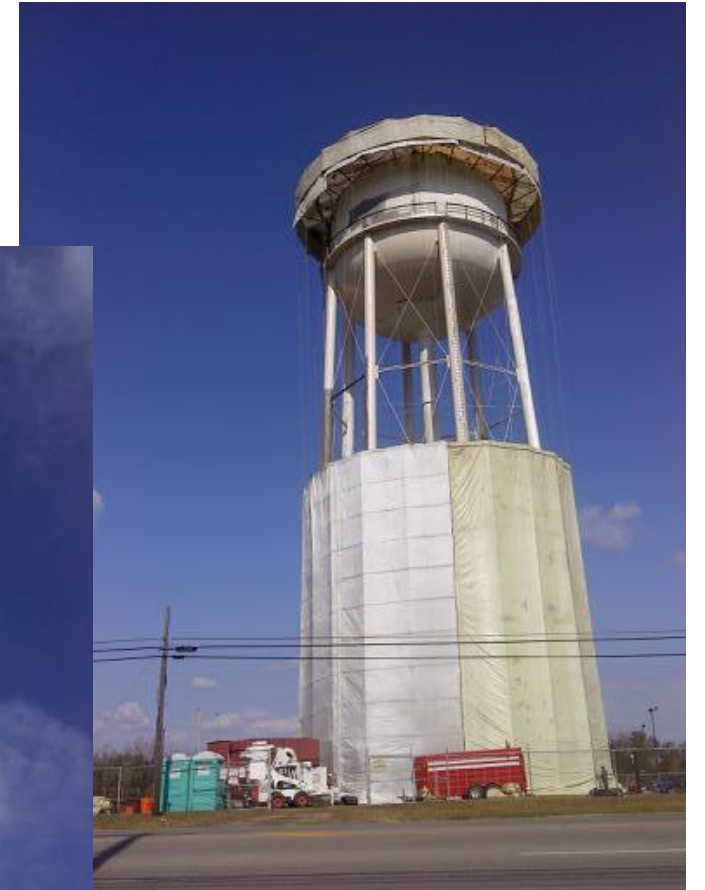
Tented Elevated Tower

Lead Paint Mitigation

- 2008 EXTECH Corrosion Analysis:
 - Confirmed lead paint in base coat
 - Recommended eventual sand blasting and recoating
 - Mitigate lead paint removal

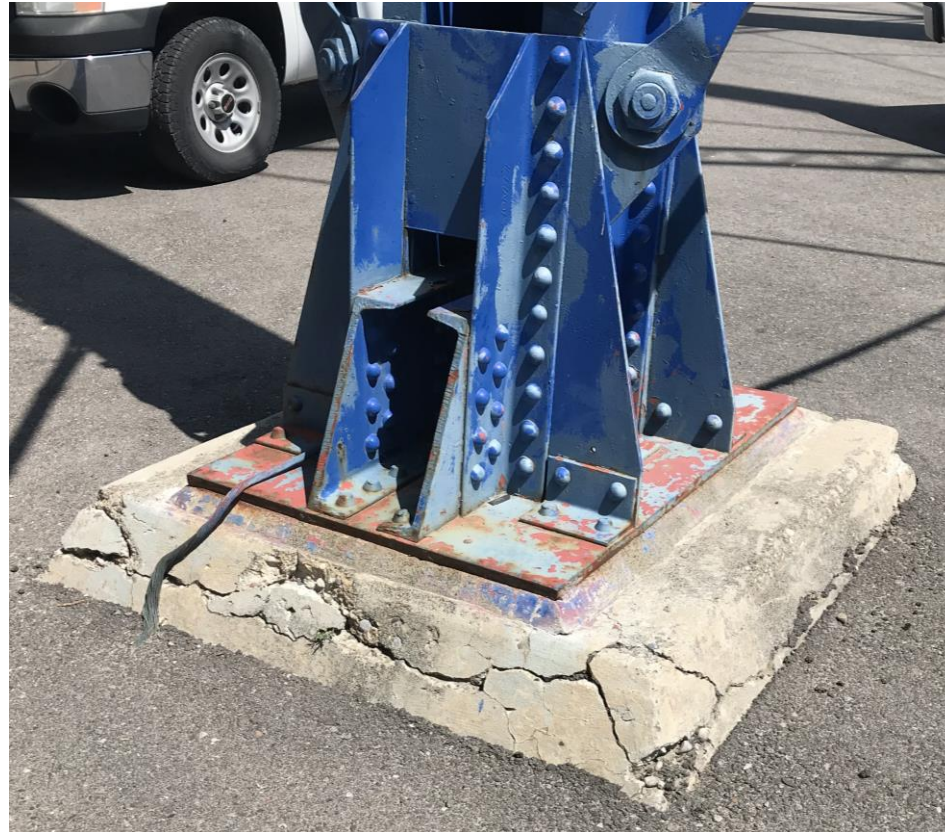
Pier Foundation Cracking

- Pier foundations
 - Last replaced in 1969
 - Surface cracking of exposed foundations

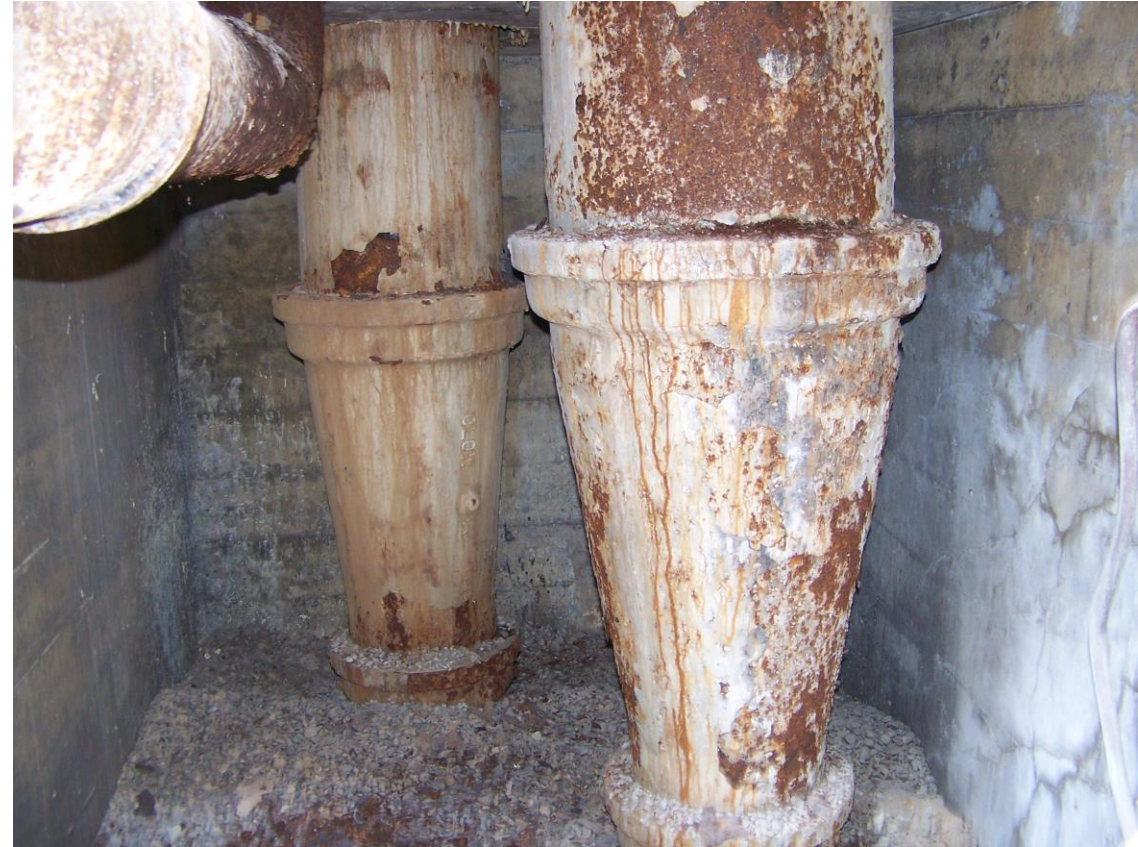
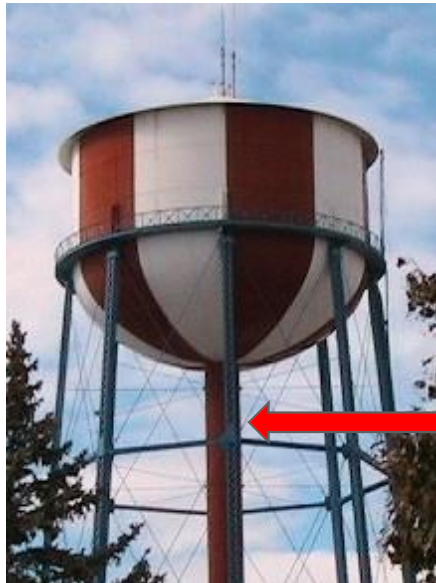
Inlet and Outlet Piping Corrosion

- Inlet and outlet piping
 - Significant corrosion in vault.
 - Cast iron pipe with lead joints.

Housed in red access tube

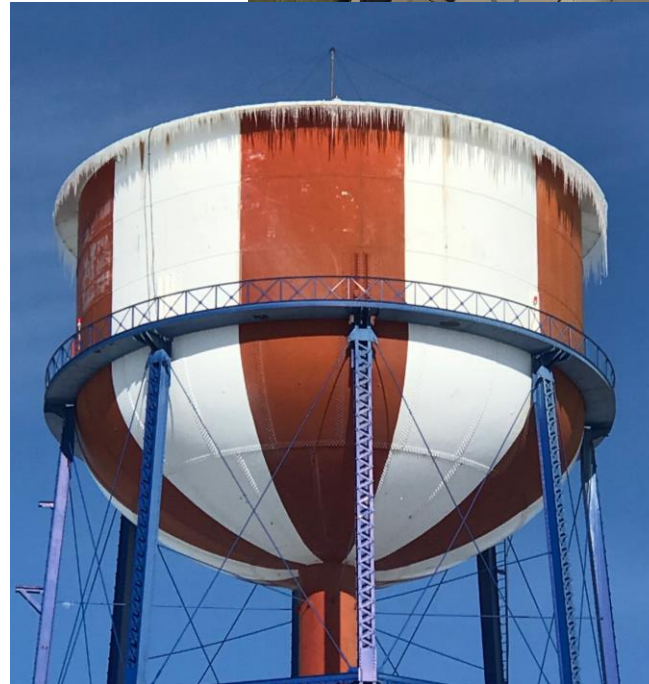
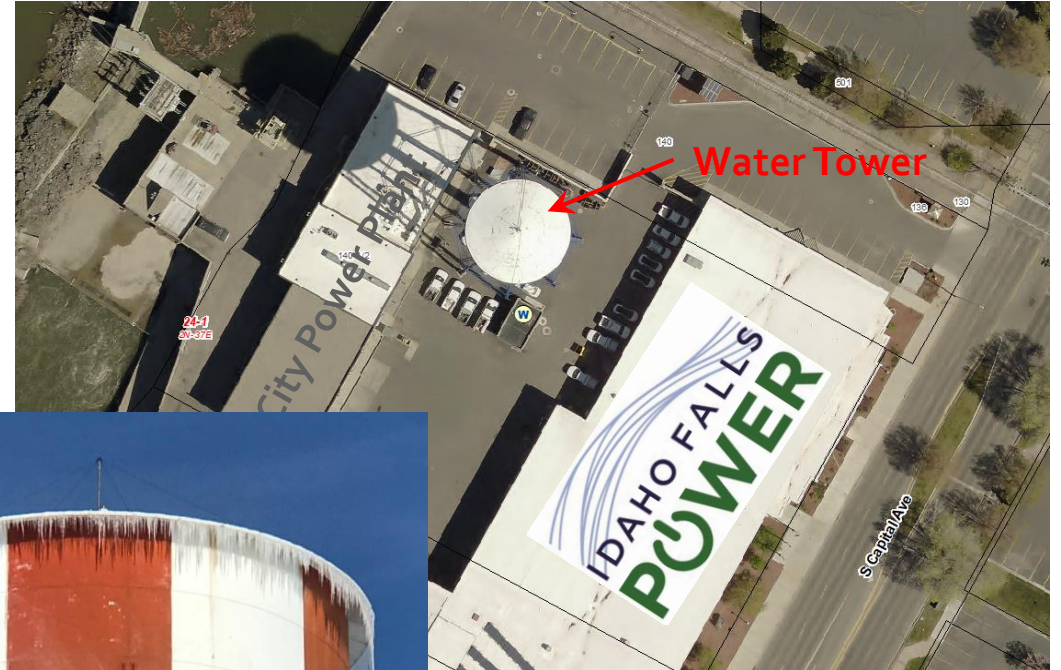
Roof Icicle Formation

- Location Safety
 - Between Idaho Falls Power's Administration Building and the Central Power Plant
 - Limits Idaho Falls Power's ability to expand.
 - IFP vehicles regularly park below tower.
 - Icicles form in winter & fall over employee walk path.

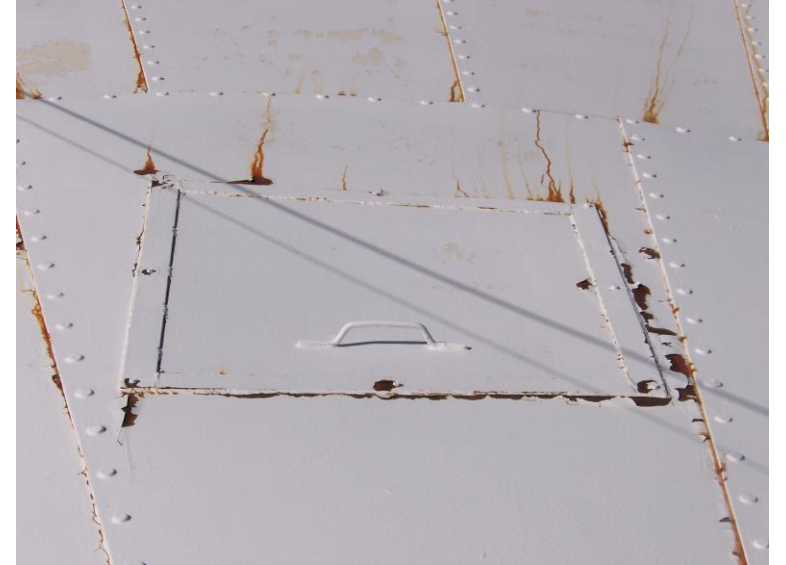
Non-compliant Roof Hatch

- Code & miscellaneous upgrades:
 - Updated safety ladder & walk path railing.
 - Miscellaneous upgrades (hatches, ventilation, etc.).
 - Replacement of deteriorated welds
- Even after improvements, tower may not meet current seismic zone requirements

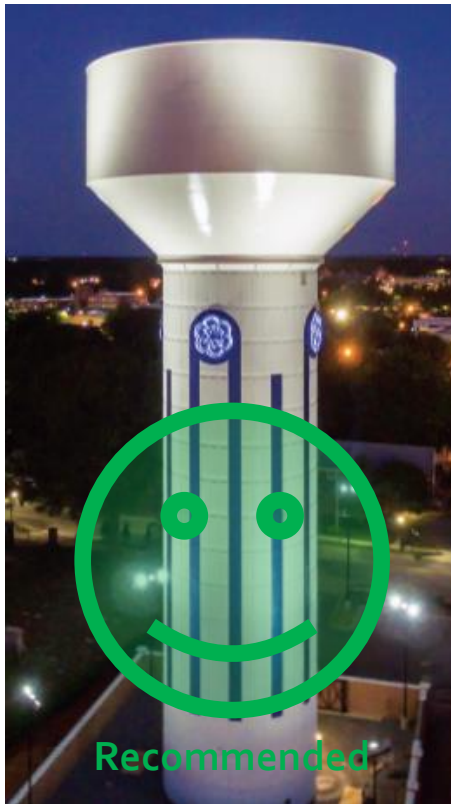
Composite Tower

Recommended

Steel Bowl With
Concrete Pedestal

Concrete construction of pedestal reduces maintenance costs over lifecycle.

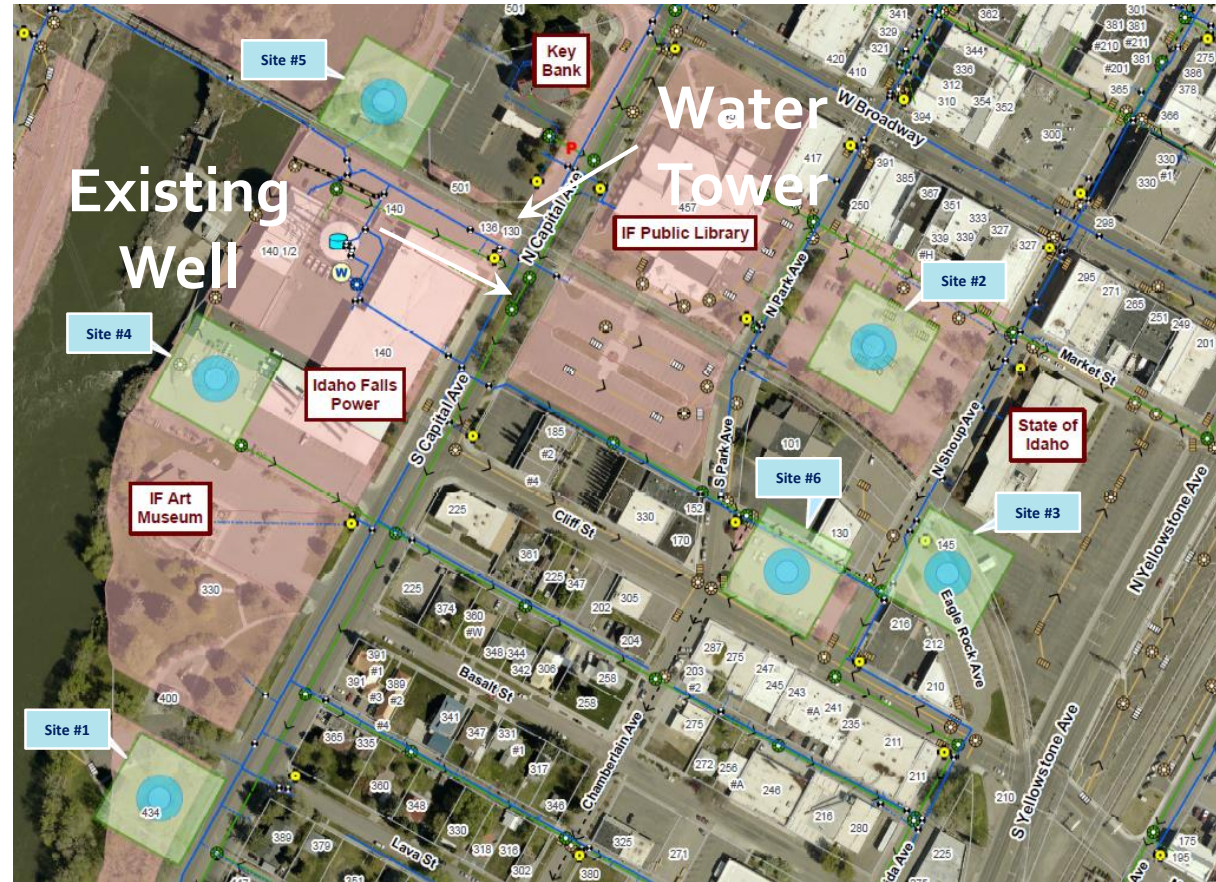
- Existing tower must remain in service until new tower is placed into service
 - New tower requires a new location
- 2018 Siting Analysis:
 - Six (6) preferred sites initially identified:
 - City-owned properties
 - Near existing well and drainage
 - Adequate room for construction
 - Sites discussed with stakeholders

- Green Square: Construction footprint**
- Outer Blue Circle: Circumference of bowl footprint**
- Inner Blue Circle: Circumference of pedestal footprint (30ft)**

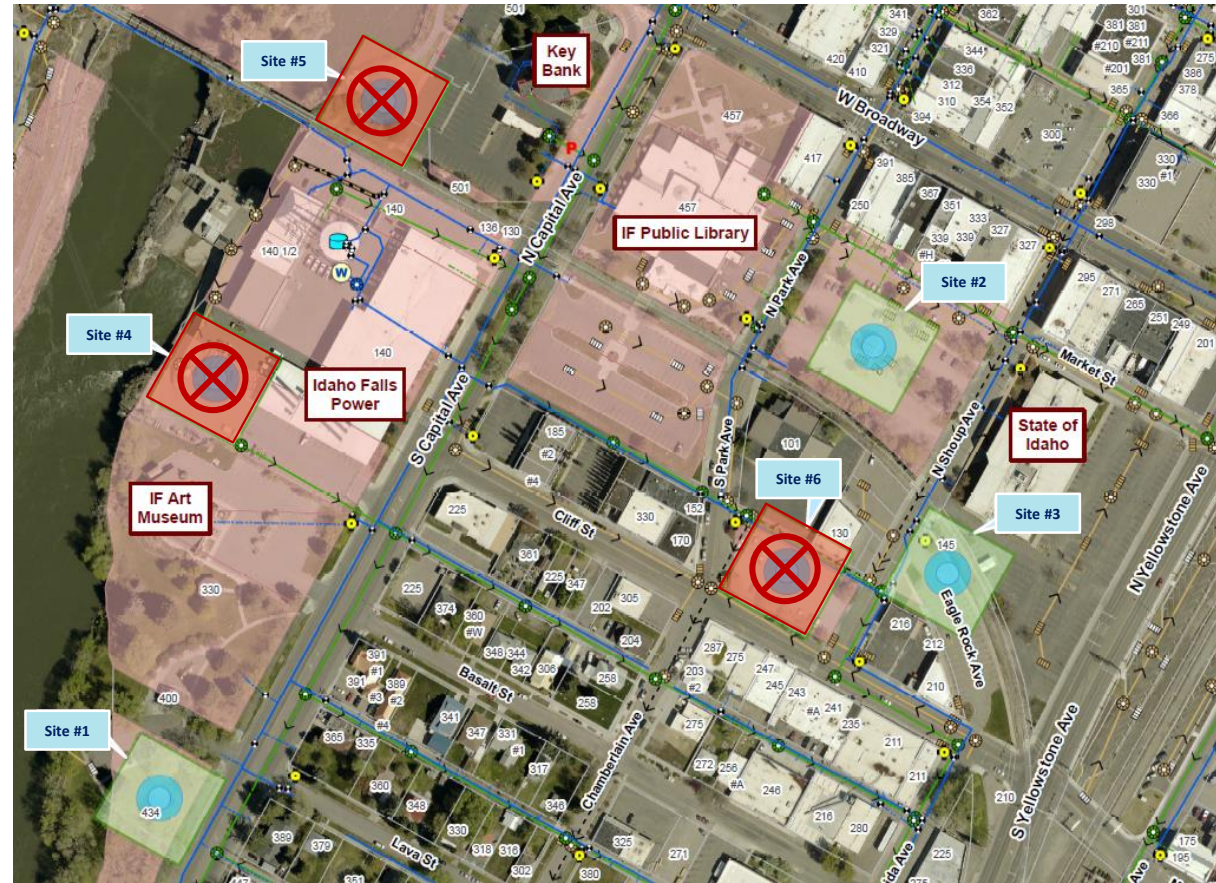
- List reduced to three (3) feasible sites after stakeholder discussions
- Consultant generated renderings for each site

- **Red Squares: Not feasible**
- **Green Square: Construction footprint**
- **Outer Blue Circle: Circumference of bowl footprint**
- **Inner Blue Circle: Circumference of pedestal footprint (30ft)**
